7.0 SOLUTION DEVELOPMENT

7.1 INTRODUCTION

7.1.1 Introduction to Solution Development

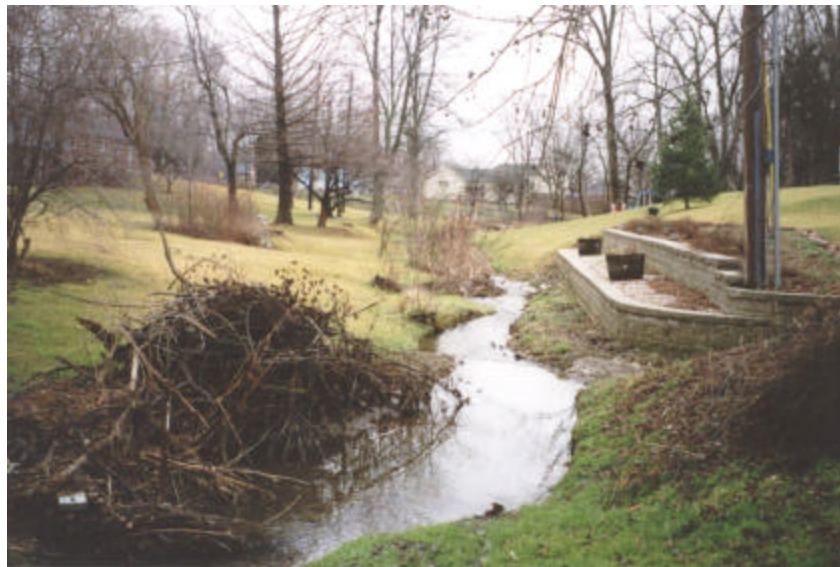
Construction near channel (right side of photo) constricts flood waters and promotes downstream erosion. Landscape debris (left side of photo) prevents the efficient flow of water and traps additional debris, creating a dam.

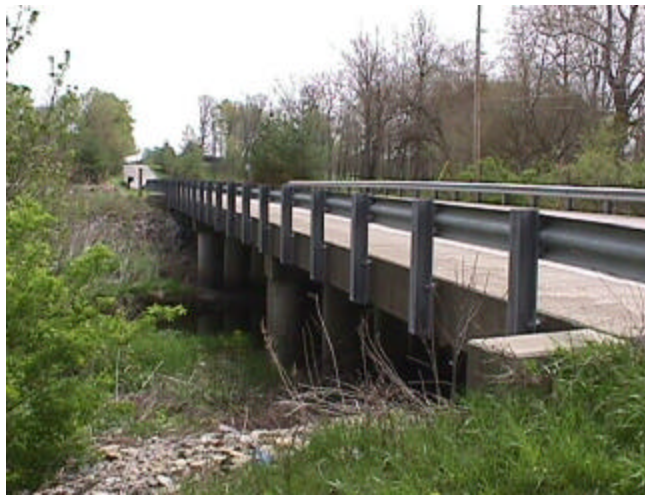
151st Street Bridge (Cool Creek)

Under existing conditions, 151st Street would be flooded during significant storm events. As the roadway elevation is low relative to the channel elevation, overtopping occurs during storm events less than the 25-year recurrence interval magnitude. As such, the crossing does not meet current INDOT hydraulic standards.

The proposed solution consists of approximately 160 LF of roadway elevation modification. Increasing the roadway to a minimum elevation of 823.50 will provide flooding protection up to the 25-year recurrence interval rainfall event, per INDOT requirements. Figure 7-1 illustrates the proposed extents of the roadway modification (**note: figures are grouped together at the end of this chapter**). The total estimated project cost for this solution is \$10,000.

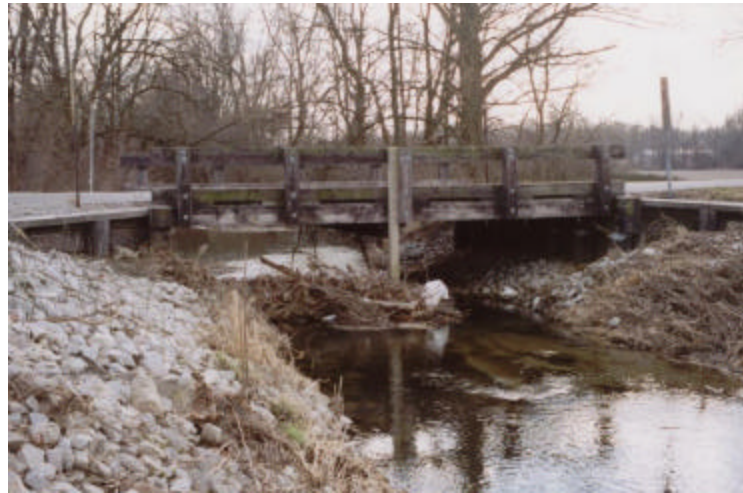
171st Street Bridge (Cool Creek)

Under existing conditions, 171st Street would be flooded during significant storm events. Similar to 151st Street, the roadway elevation is low relative to the channel elevation. However, the bridge opening is small at 171st street, adding to the hydraulic restriction. Overtopping occurs during storm events less than the 25-year recurrence interval magnitude. As such, the crossing does not meet current INDOT hydraulic standards.

The proposed solution consists of approximately 320 LF of roadway elevation modification and the removal and replacement of the existing bridge. Bridge replacement is necessary to prevent excessive headwaters resulting from a 100-year storm. Replacing the bridge and raising the roadway elevation will provide flooding protection up to the 25-year recurrence interval rainfall event, per INDOT requirements. Figure 7-2 illustrates the proposed improvements. The total estimated project cost for this solution is \$700,000.

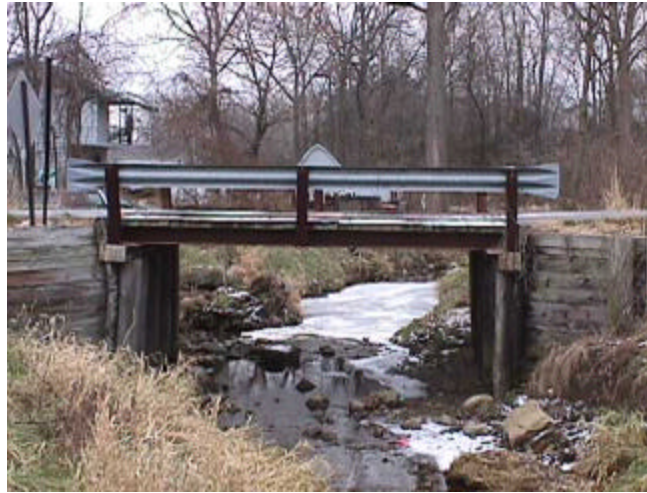
Gurley Street (Anna Kendall)

Gurley Street is a minor dead-end public roadway with an average roadway width of 11 feet. The existing bridge consists of wooden abutments, 45-degree wooden wingwalls, steel deck supports and a wooden deck. The bridge is in fair to poor structural condition. Under existing conditions, the Gurley Street crossing would be overtopped during the 50-year and 100-year storm events. The overtopping occurs approximately 75 feet north of the bridge at a vertical sag in the roadway. Our independent calculations indicate that this bridge would also be overtopped during the 25-year storm event. However, as this roadway is minor it likely has an ADT well below 1,000. As such, INDOT standards would specify a 10-year storm be used as the criteria for maximum flow before roadway overtopping.

Given the structural condition of the existing bridge, it is recommended that it be replaced. The proposed solution consists of a new single-span concrete bridge. The new bridge will replace the failing wooden structure and provide additional hydraulic capacity. The proposed bridge, as depicted in Figure 7-3, would provide adequate conveyance for the 10-year storm without roadway overtopping. The total estimated project cost for this solution is \$280,000.

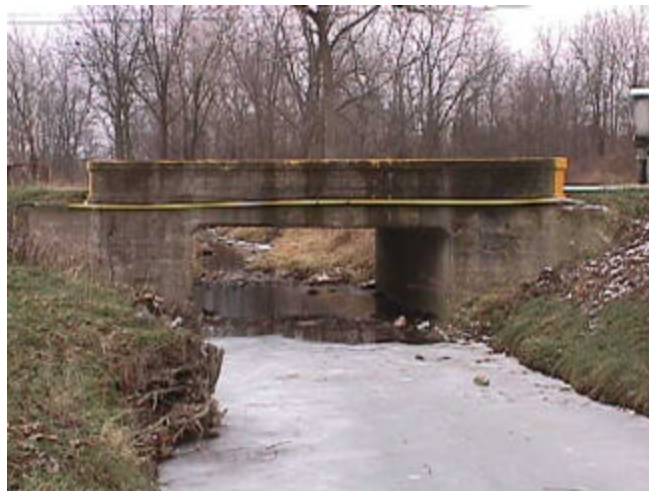
Cherry Street (Anna Kendall Drain)

Cherry Street is a 2-lane local roadway with a rectangular concrete bridge opening. The bridge opening area at Cherry Street is smaller than nearby bridges, including Gurley, Union, and Park Streets. Under existing conditions, the Cherry Street crossing would be overtopped during the 50-year and 100-year storm events. This crossing creates a significant hydraulic restriction in the Anna Kendall Drain, raising the 100-year water surface elevation by approximately three (3) feet. Replacing this bridge would provide significant improvements to the upstream floodplain and would help to lower the 100-year floodplain elevation in the downstream reach of the J.M. Thompson Drain.

The proposed solution consists of a new single-span concrete bridge. The new bridge will replace the current small opening area and will provide adequate hydraulic capacity at the crossing. The proposed bridge, as depicted in Figure 7-4, would provide adequate conveyance for the 25-year storm without roadway overtopping. Furthermore, the hydraulic grade line would be lowered significantly through this reach of drain, helping to alleviate flooding problems upstream of Cherry Street. The total estimated project cost for this solution is \$340,000.

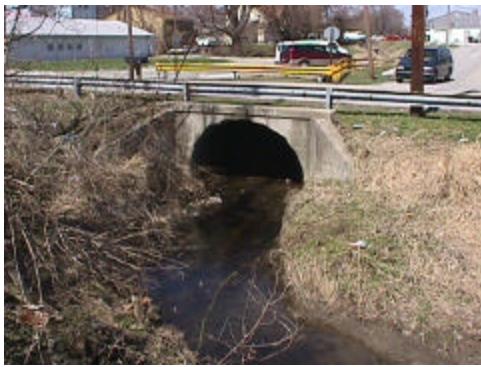
W. Jersey Street Culvert (J.M. Thompson Drain)

This crossing is impacted by the backwater effects caused by the Anna Kendall Drain, immediately downstream of W. Jersey Street. The proposed improvements to the Cherry Street will help to lower the 100-year floodplain approximately 0.6 feet near the mouth of the J.M. Thompson Drain. However, this is a low-lying area and would nonetheless be subject to flooding during a 100-year recurrence interval rainfall event.

Replacing the culvert at W. Jersey Street would not have a significant hydraulic impact, given the high tailwater created by the Anna Kendall Drain. As such, it is recommended that no improvements be made at this location.

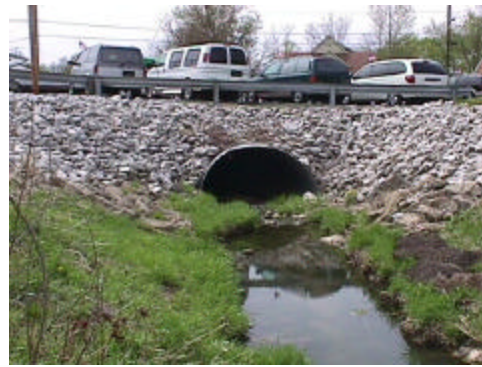
Upstream of Main St. (J.M. Thompson Drain)

The Main Street (SR 32) crossing, immediately upstream (north) of W. Jersey Street, creates a significant hydraulic restriction during the 100-year storm, causing flooding in upstream residential areas. In order to reduce flooding potential upstream of SR 32, it will be necessary to replace the existing CMP arch culvert at Main Street with a 12' x 8' box culvert, as illustrated in Figure 7-5. The total estimated construction cost to replace this culvert is \$310,000.

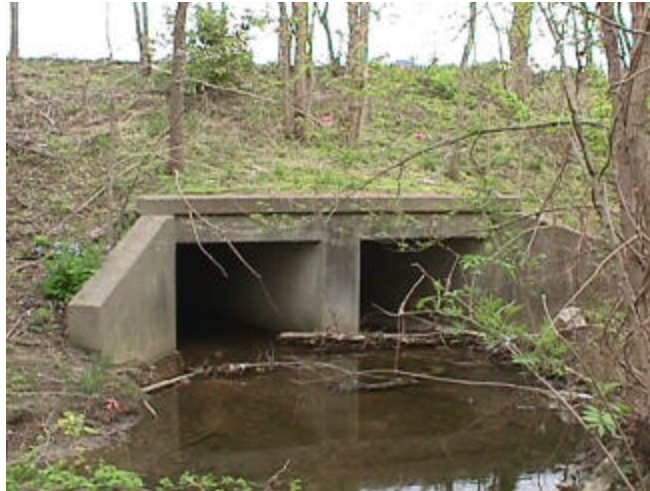
US 31 Culvert (Highway Run)

The US 31 crossing, in the lower reaches of the Highway Run, creates a severe hydraulic restriction. Furthermore, the private drive immediately downstream of US 31 creates an additional hydraulic restriction. The resulting headwaters impact the Walter Street/Walter Court neighborhood, causing widespread flooding during a 100-year storm. As such, it will be necessary to replace both culverts in order to lower the 100-year floodplain to a reasonable level.

The proposed culvert replacements, as depicted in Figure 7-6, will consist of replacing the twin 5' x 4' box culverts (private crossing) with a 10' x 6' box culvert and adding a 60" RCP culvert next to the existing box culverts under US 31. It was assumed that boring and jacking would be necessary at US 31, given the depth of the culvert and traffic volumes. The culvert replacements will help to relieve flooding potential upstream and will reduce flow velocities downstream of US 31. The total estimated construction cost to replace both culverts is \$800,000.

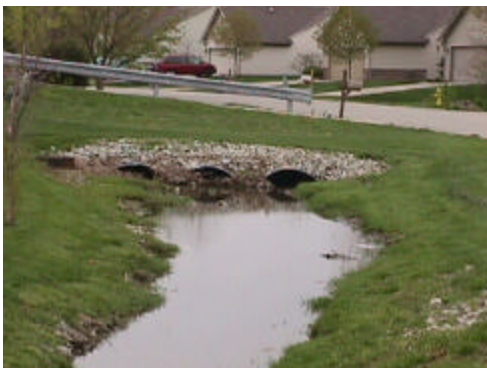
*Private Drive along Walter Street
(Highway Run)*

Three adjacent stream crossings, beginning at the Walter Drive (downstream) crossing and ending at the Walter Court (upstream) crossing, are overtopped during the 10-year storm. The existing crossings, each consisting of triple CMP arch culverts, are partially filled with sediment and do not provide adequate flow conveyance. Replacing each crossing with a single 12' x 4' box culvert, in conjunction with minor channel reshaping, would provide adequate conveyance for the 10-year storm without roadway overtopping. The proposed improvements are illustrated in Figure 7-7. The total estimated construction cost to replace both culverts is \$200,000.

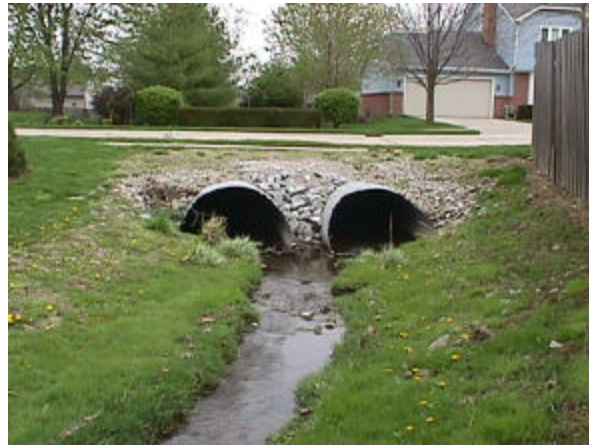
Thornberry Drive (Highway Run)

The Thornberry Drive culvert does not adequately convey the 10-year recurrence interval rainfall event. This is partially due to the hydraulic restriction created by the Walter Street/Court culverts (described above in Section 7.4.7). Replacing the three culverts as described in Section 7.4.7 and replacing the existing Thornberry Drive culverts with a 11' x 3.5' box culvert (see Figure 7-8) will provide adequate conveyance for the 10-year storm. The total estimated construction cost to replace the Thornberry Drive crossing is \$80,000.

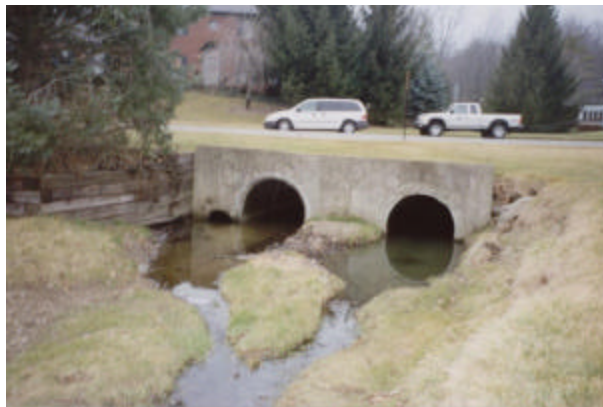
Carmel Drive (Hot Lick Creek)

The existing twin 48-inch concrete pipes do not provide adequate conveyance for a 10-year recurrence interval rainfall event. Nearby residential structures would be vulnerable to flood waters resulting from roadway overtopping. As such, it will be necessary to replace the existing culverts such that a 10-year storm flow can be adequately conveyed without roadway overtopping.

The proposed solution consists of 120 lineal feet of a 4-foot rise by 10-foot span reinforced concrete box culvert with 45-degree wingwalls at each end. This improvement will reduce the 10-year peak water surface elevation at Carmel Street by approximately 0.6 feet, approximately 0.4 feet below the roadway elevation. Peak 10-year flow velocities at the downstream end of the Carmel Drive culvert will be reduced from 9.3 feet per second (fps) to just over 5 fps.

It is also recommended to re-grade approximately 120 lineal feet of the open channel upstream of the Carmel Drive culvert so as to provide additional flow capacity and better erosion protection. This is necessary to curb channel erosion that is beginning to occur in this area. Figure 7-9 illustrates the proposed culvert replacement and channel improvement. The total estimated project cost for this solution is \$90,000.

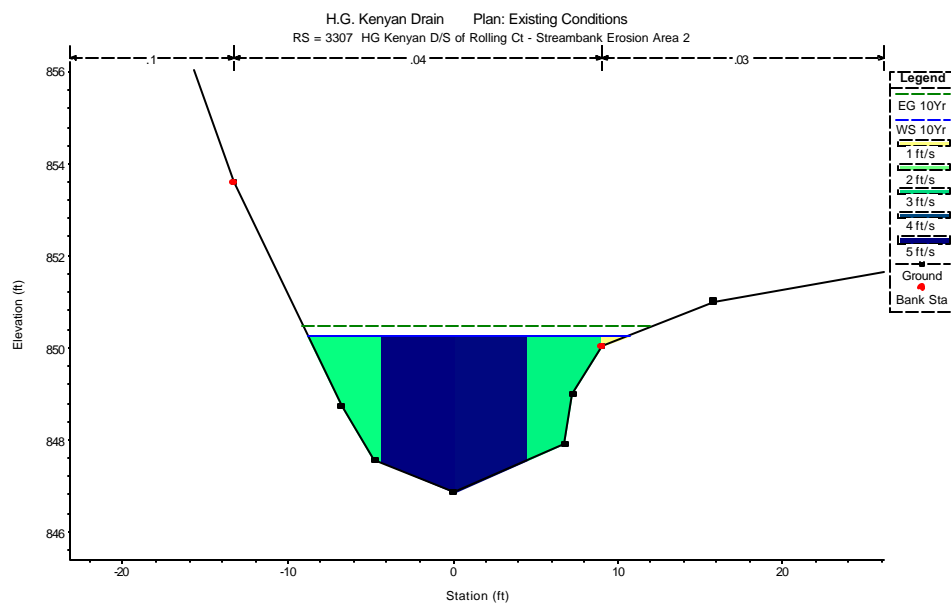
Velocity Distribution: H.G. Kenyon Drain downstream of Rolling Ct.

Flow velocities are moderate in this area. The 10-year peak flow velocity of approximately 5 feet per second (fps), will require some vegetation reinforcement but should not require any intensive improvements. The 10-year flow velocity distribution at this location is illustrated below.

It is recommended that 250 lineal feet of the Highway Run streambank (right side only) be graded to a slope not exceeding 3:1 (horizontal:vertical) and reinforced with vegetative protection. This will protect the soils and increase the friction coefficient along the streambank, thus helping to reduce flow velocities. The modified streambank should be reinforced with an erosion matting and grass seed specifically designed for open channels (often referred to as “ditch mix”). The proposed improvements for this area are similar to those described in Section 7.6.1. Streambank reinforcement should be implemented a minimum of 3 *vertical feet* from the channel bottom.

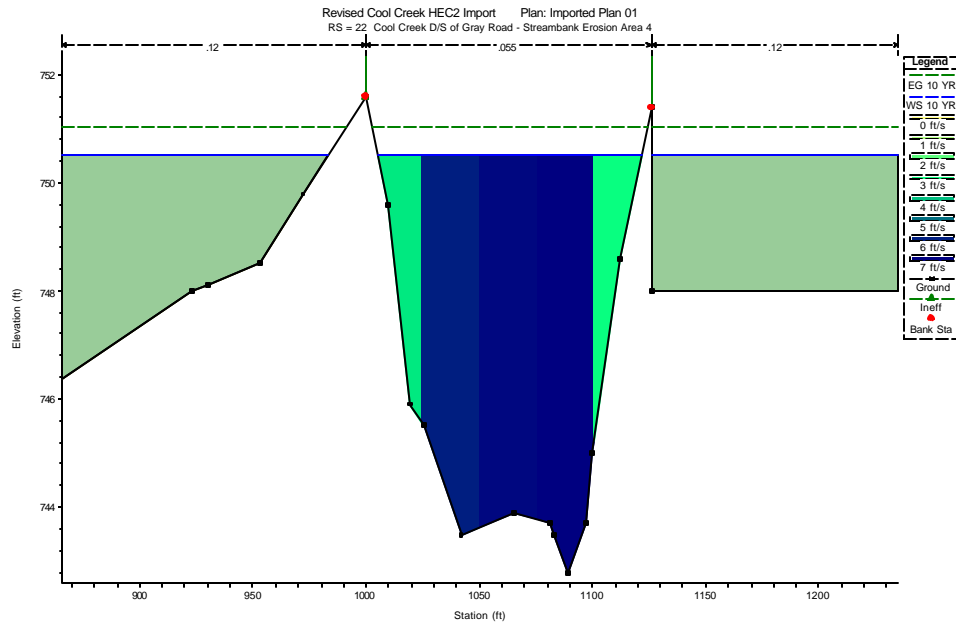
Streambank erosion is occurring in the Cool Creek downstream of Gray Road (see Figure 7-14). This erosion continues around a sharp bend in the channel for a total length of approximately 200 lineal feet. The streambank along the outside edge of the channel bend is subject to severe erosion. The 10-year peak flow velocities at this location are very high, exceeding 7 fps at the center of the channel. Flow velocities in this range will cause significant erosion in unprotected areas. The 10-year flow velocity distribution at this location is illustrated on the following page.

It is recommended that 200 lineal feet of the Cool Creek streambank be reinforced using a *vegetated geogrid* as shown in the illustrations and photographs on the following pages. This will help to stabilize the streambank from the channel bed to the top of bank with a combination of dense vegetation, geotextile fabric, and boulders.

Riprap toe protection should be installed along the toe of streambank to provide additional protection against streambank incision. The riprap toe protection should be provided using brushmattress technique previously discussed. Streambank reinforcement should be implemented a minimum of 6 *vertical feet* from the channel bottom.

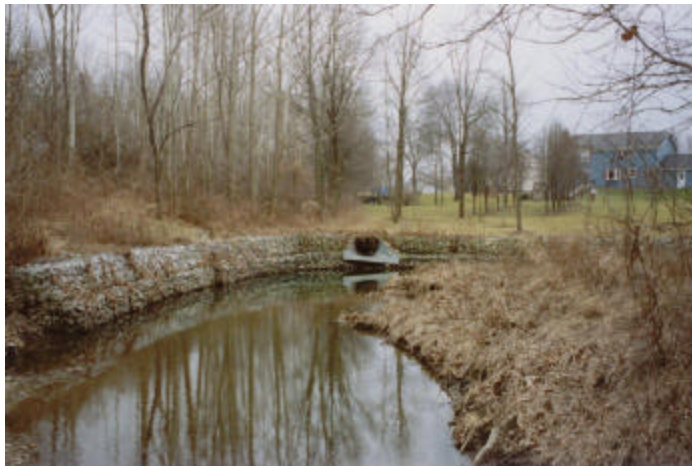
Example of Gabion channel bank stabilization on Cool Creek near Underwood Court in City of Carmel

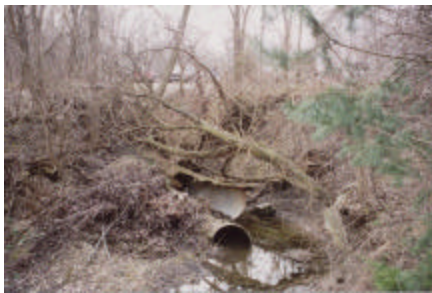
Breach in abandoned railroad embankment (note deteriorated CMP, pipe in foreground appears to be a bucket or rubbish container)

The area surrounding the existing impoundment is potentially unsafe given the existing embankment breach and the location/alignment of the 48-inch outlet. Three options are available at this site:

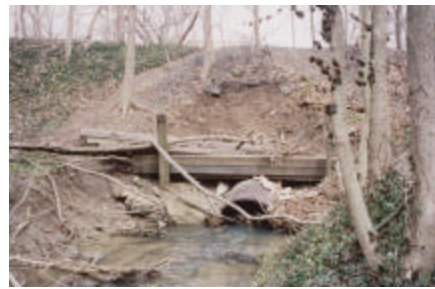
Upstream end of existing 48-inch culvert outlet (note pipe section has fallen into creek and embankment is eroding above culvert)

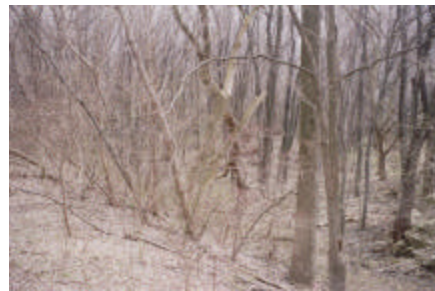
Looking at impoundment area from top of abandoned railroad embankment (note area is heavily forested)

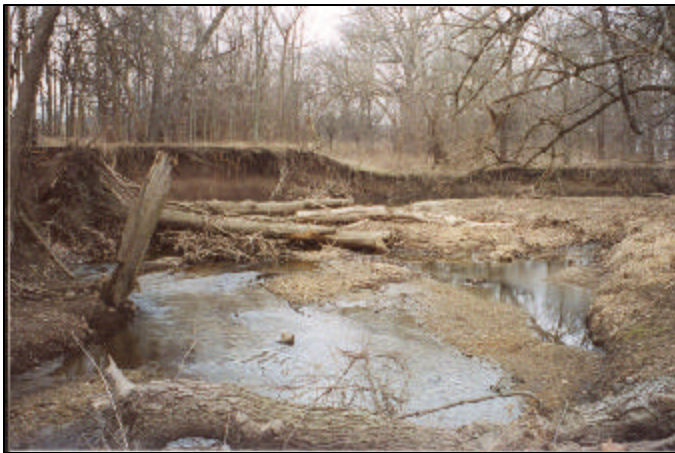
COOL CREEK WATERSHED MANAGEMENT PLAN
Figure 7-13
Cool Creek
U/S of White River Confluence

**Slightly Upstream of Confluence with White River
Severe Bank Erosion and Log Jam**

It is recommended that 1500 lineal feet of the Cool Creek streambank be re-graded to a slope not exceeding 2:1 (horizontal:vertical) and reinforced using a *brushmattress technique* as illustrated on the following page. This will help to stabilize the streambank from the channel bed to the top of bank with a combination of dense vegetation, geotextile fabric, and riprap. Streambank reinforcement should be implemented a minimum of 4 vertical feet from the channel bottom. Gabion basket stabilization would also be a viable option at this location.

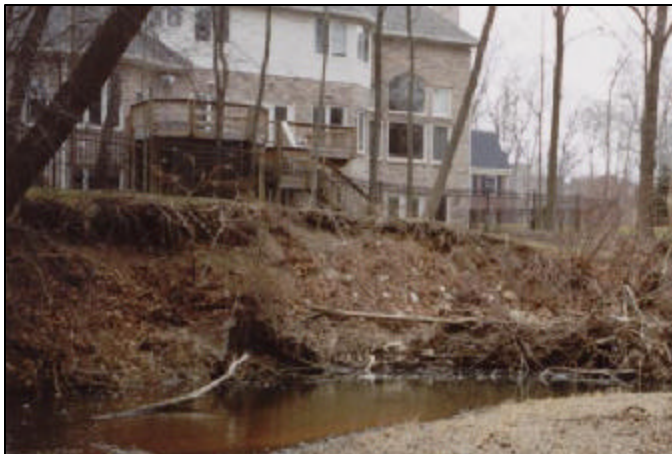
COOL CREEK WATERSHED MANAGEMENT PLAN
Figure 7-14
Cool Creek
D/S of Gray Road

**Cool Creek
Severe Bank Erosion and Log Jam**

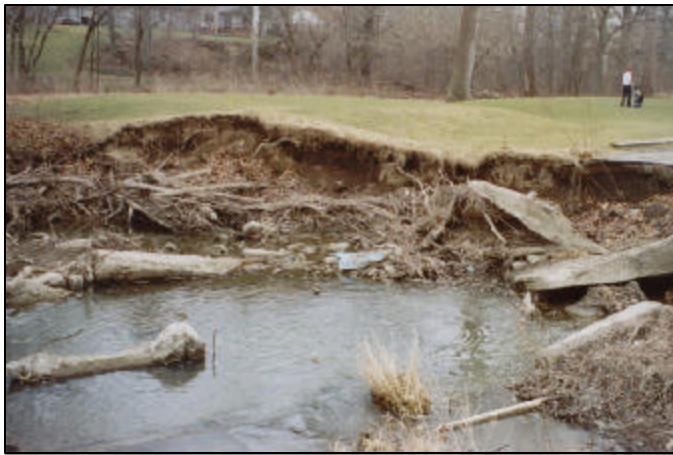
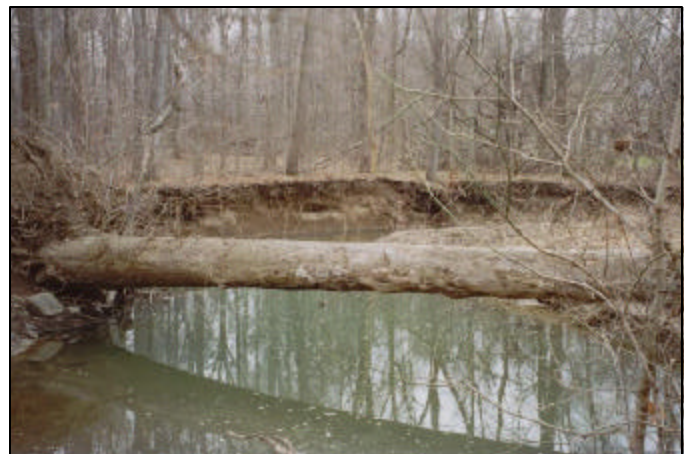
**Figure 7-15
Cool Creek
U/S & D/S of Hot Lick Creek**

**Cool Creek in Brookshire Golf Course
Severe Bank Erosion, Cart Path Fallen into Creek**

**Cool Creek
Severe Bank Erosion**

It is recommended that a total of 575 lineal feet of the Cool Creek streambank be reinforced using the *brushmattress technique* as described in Section 7.6.3. Streambank reinforcement should be implemented a minimum of 3 vertical feet from the channel bottom.

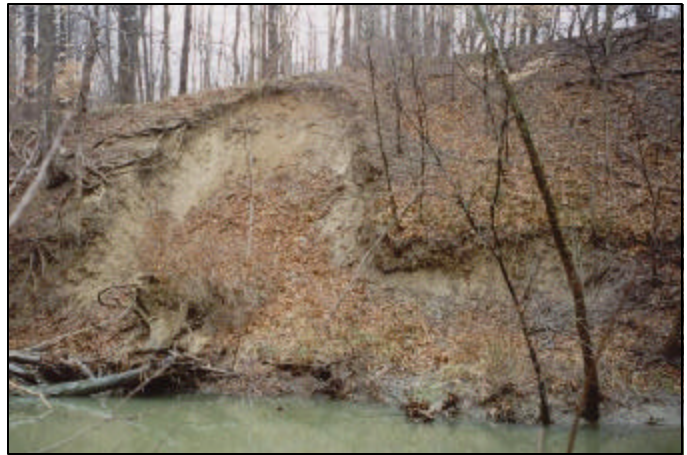
Figure 7-16
Cool Creek
U/S of 131st Street

Cool Creek
Severe Bank Erosion, Tree Fallen into Creek

Protecting this reach of the Cool Creek will require some regrading, slope protection, and vegetative reinforcement to protect the channel banks from continued erosion. It is recommended that 150 lineal feet of the Cool Creek streambank be re-graded to a slope not exceeding 3:1 (horizontal:vertical) and reinforced with a combination of riprap (w/geotextile fabric base) and live woody stakes (referred to as the *joint plantings* technique, see illustration on following page). The live stakes will take root along the reinforced streambank and strengthen the channel. Furthermore, the live stakes will grow and shroud the riprap with a natural vegetative cover. Streambank reinforcement should be implemented a minimum of 4 vertical feet from the channel bottom.
